### **Site Visit to Evaluate Erosion Potential near Colusa Mitigation Area**

| <b>FROM:</b><br><br>Chris Jones | <b>SUBJECT:</b><br><br>Site visit to evaluate erosion potential near Colusa Mitigation Area |

## EROSION EVALUATION NEAR COLUSA MITIGATION AREA

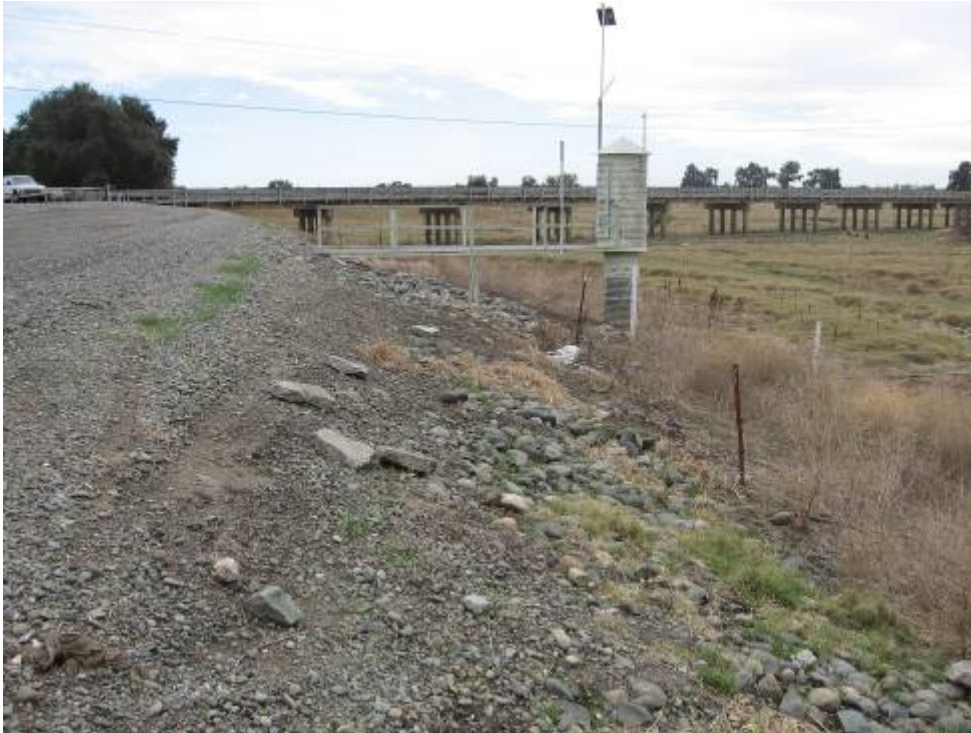
- The rock revetments at locations 1 and 2 are partially buried in finer sediment. Field staff indicate material has accumulated atop the cobble and blasted rock. There is no sign of deterioration. (See **Figure 15** and **Figure 16**). An additional factor of safety exists at locations 1 and 2 because where high velocities are modeled to occur, the land immediately behind the levees is filled to approximately the same elevation as the levee tops, creating parking lots that effectively increase the width of the levees at these places.

**Figure 15: Location 1, Northern bank along entrance to Colusa Bypass**

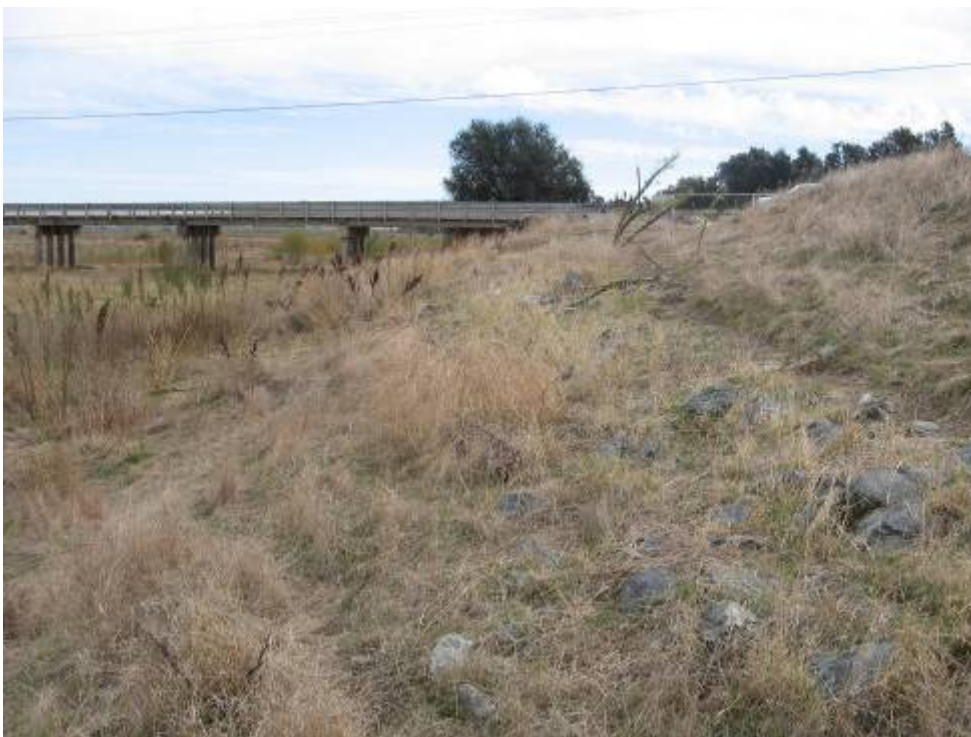
**Figure 16: Location 2, Southern bank along entrance to Colusa Bypass**

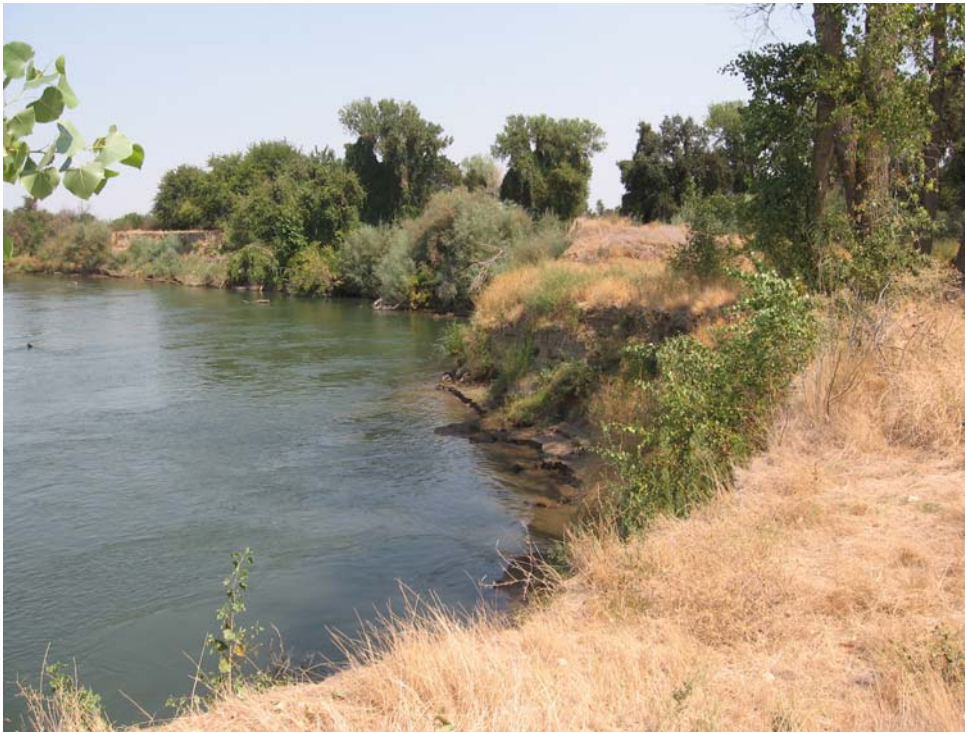
- DWR has recognized the erosion activity at location 3. There is rock revetment along the northern portion, and DWR has already built a set-back levee along the southern portion of Cruise 'n Tarry because the main channel is active against that bank. (See **Figure 17** and **Figure 18**).

**Figure 17: Location 3, Bank of Cruise and Tarry**

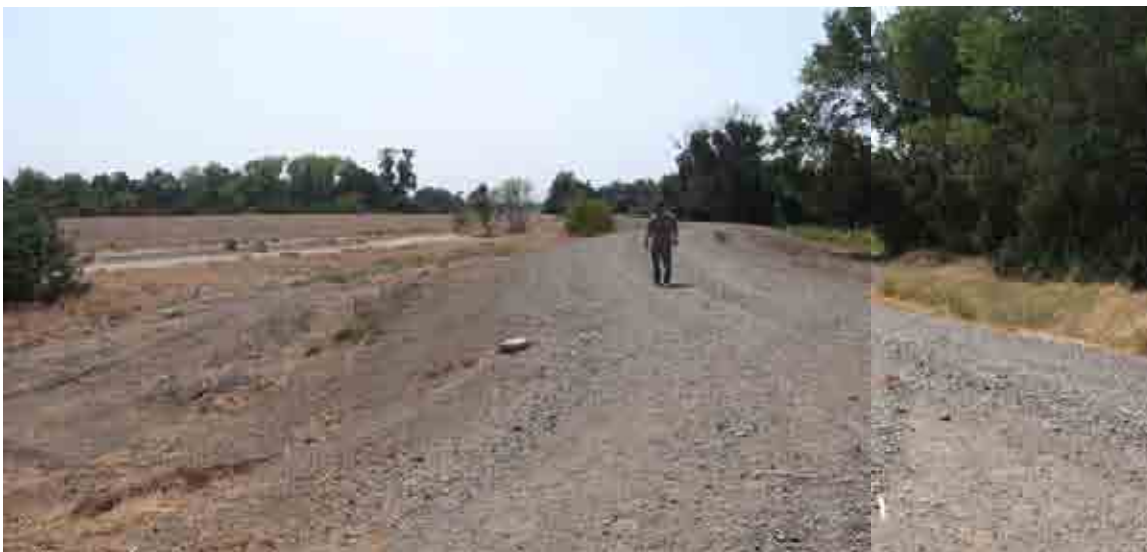
**Figure 18: Location 3, Original Levee & Setback Levee at Cruise and Tarry**

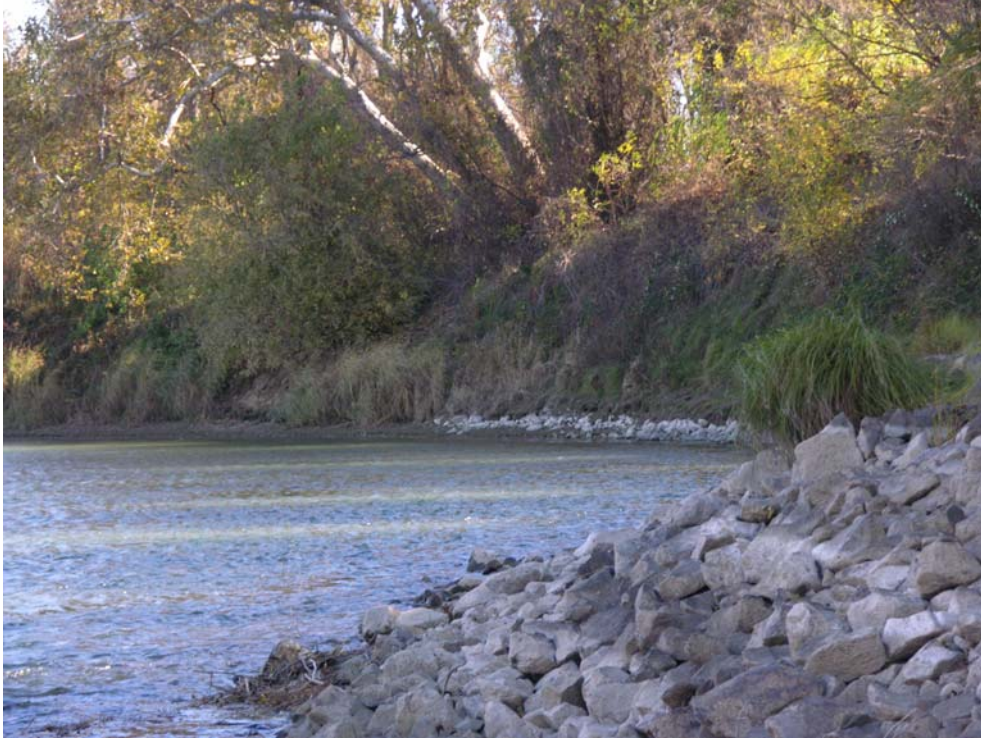
- At location 4, the velocity increase of 0.24 ft/sec modeled to occur due to restoration is focused in the main channel, resulting in a maximum velocity of 3.74 ft/sec approximately 230 ft from the toe of the levee during the modeled flow conditions. While it is true that if the main channel migrates eastward, erosive force on the levee will increase, this potential condition would be the result of fluvial process in the river at large, rather than the proposed restoration at Ward Tract. In any case, the blasted rock revetment of the levee should well withstand potential velocities in the 4 ft/sec range if the river channel does shift eastward, as well as the velocities of up to 0.75 ft/sec projected to occur near the levee tip with the existing river alignment. (See **Figure 19** and **Figure 20**).

**Figure 19: Location 4, Rock Revetment and Mature Vegetation**

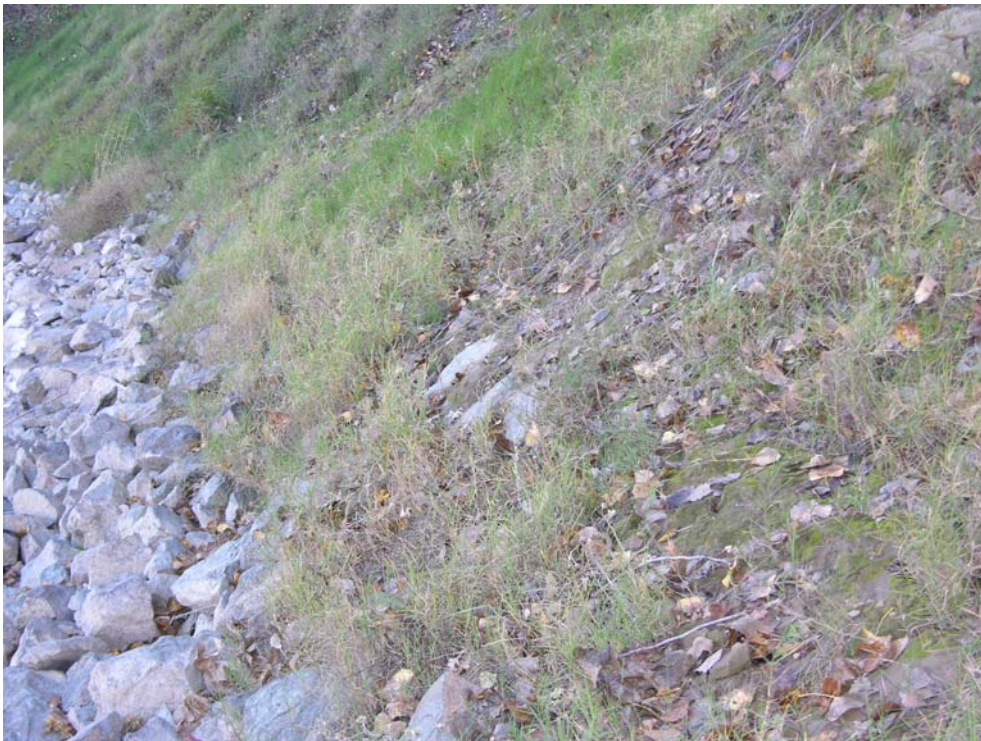
**Figure 20: Location 4, Transition of Underlying Rock Revetment to top surface of soil and vegetation**

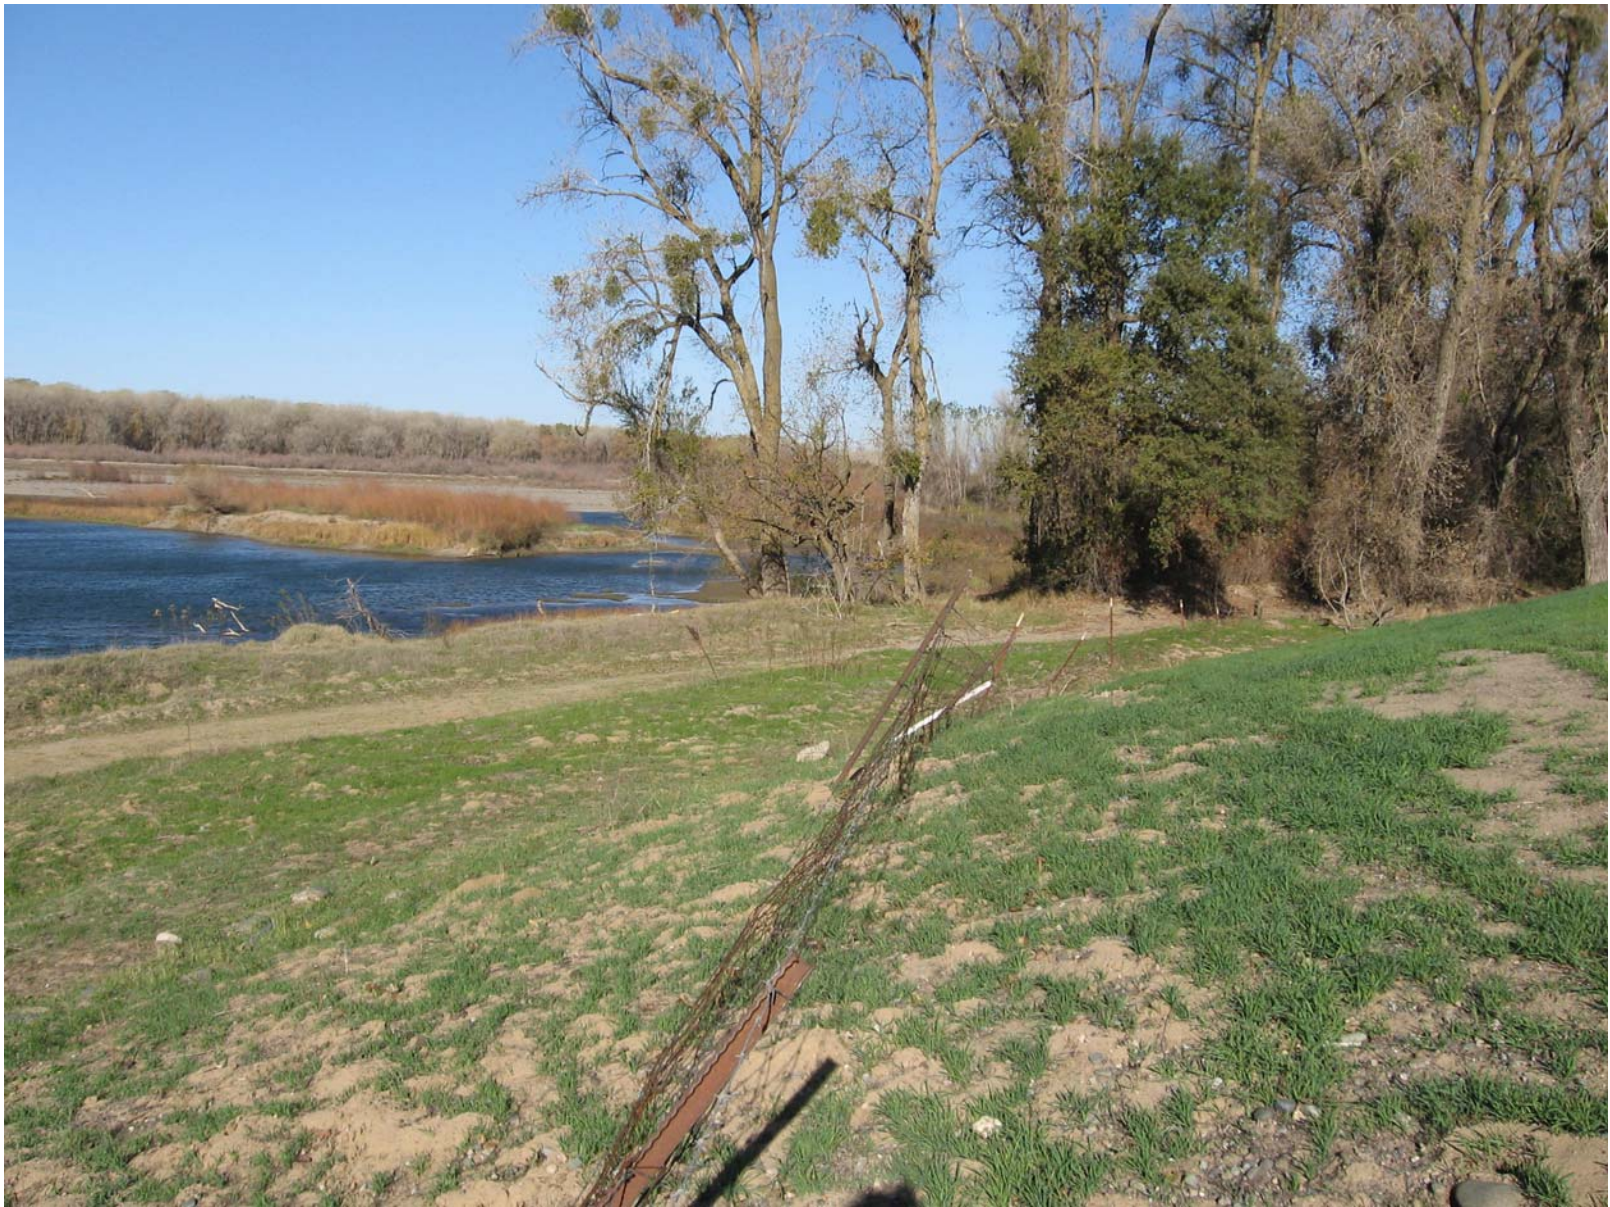
Photo  
1

Locations 1 and 2 consist of the North and South levees immediately upstream of the Colusa Weir. Each of these locations contains revetment consisting of cobbles covered with soil. In addition, the buried South levee revetment (Location 2) contains blasted rock. Sutter Maintenance Yard personnel have not observed erosion at these locations in the past. Because of the lack of historical erosion issues at these locations and the presence of revetment, these sites were determined to be safe from potential erosion due to the small flow velocity increases modeled to result from the proposed mitigation project.

Levee at Location 1 (looking NW)

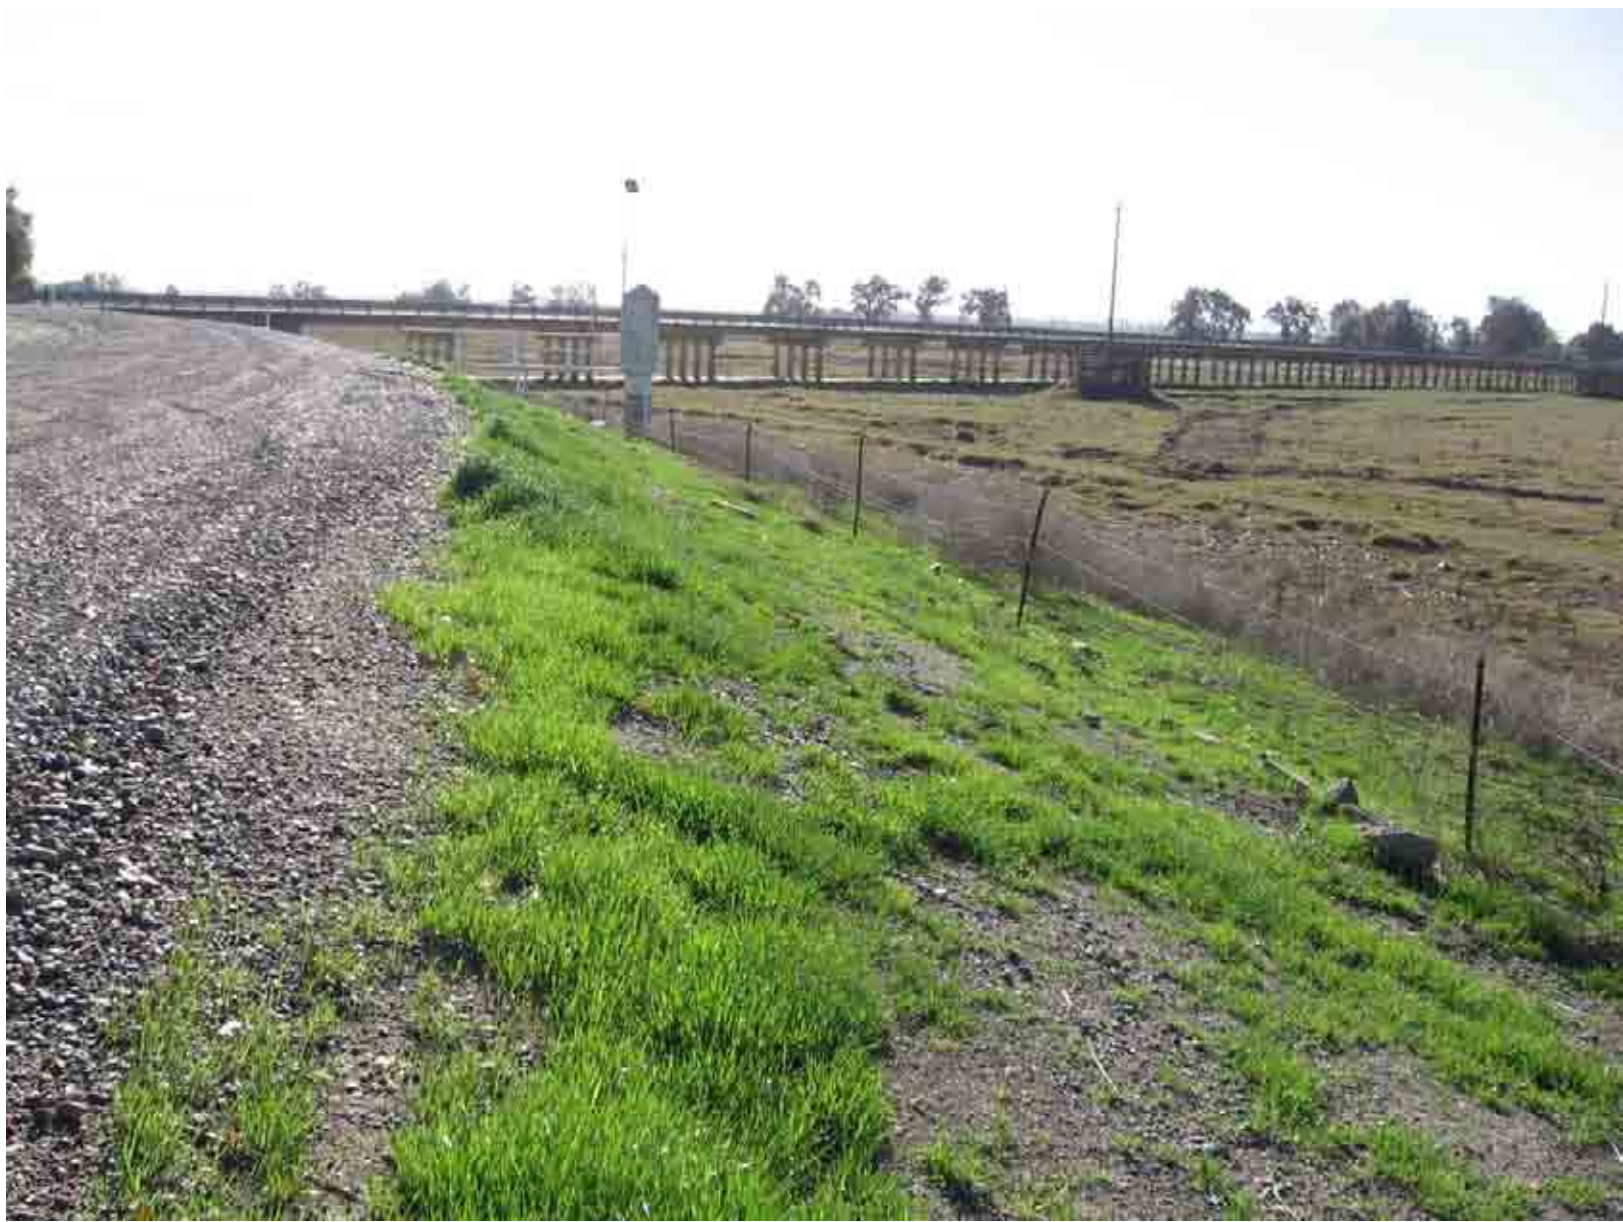
Photo  
2

Levee at Location 1 (looking SE)

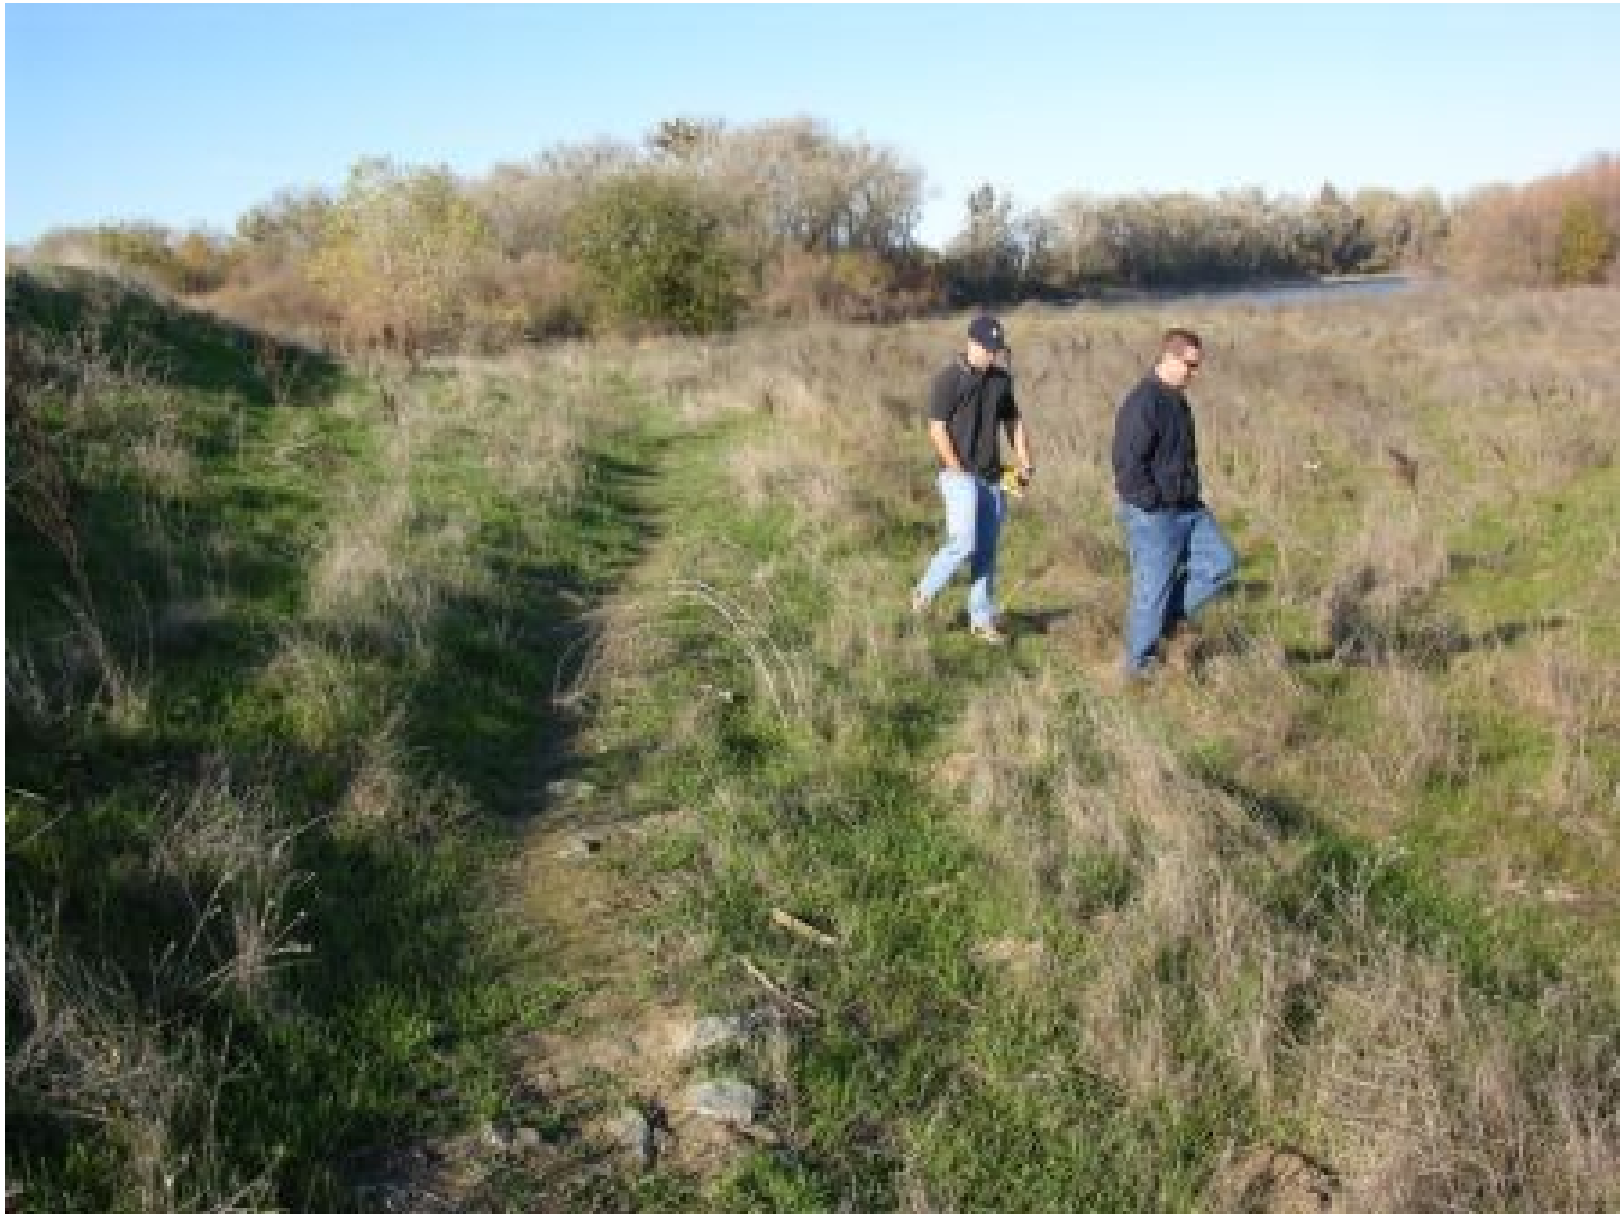
Photo  
3

Levee at Location 2 (looking W)

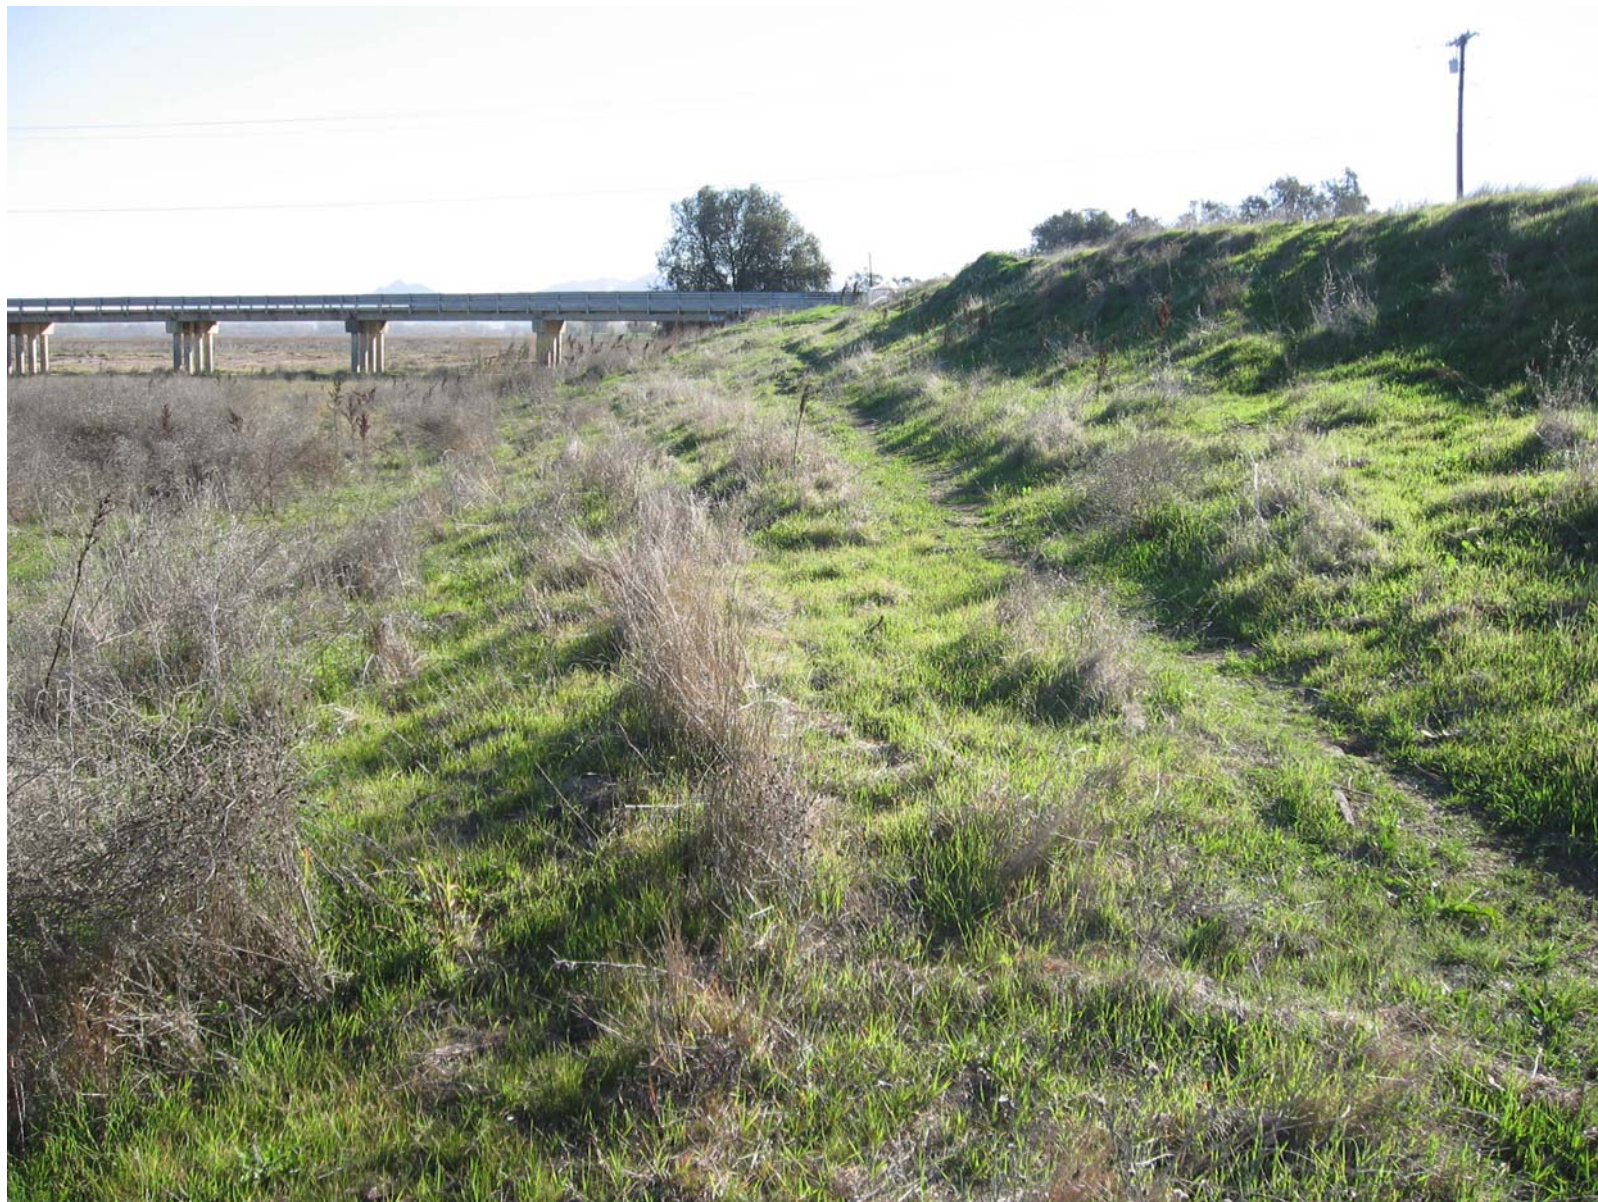
Photo  
4

Levee at Location 2 (looking E)

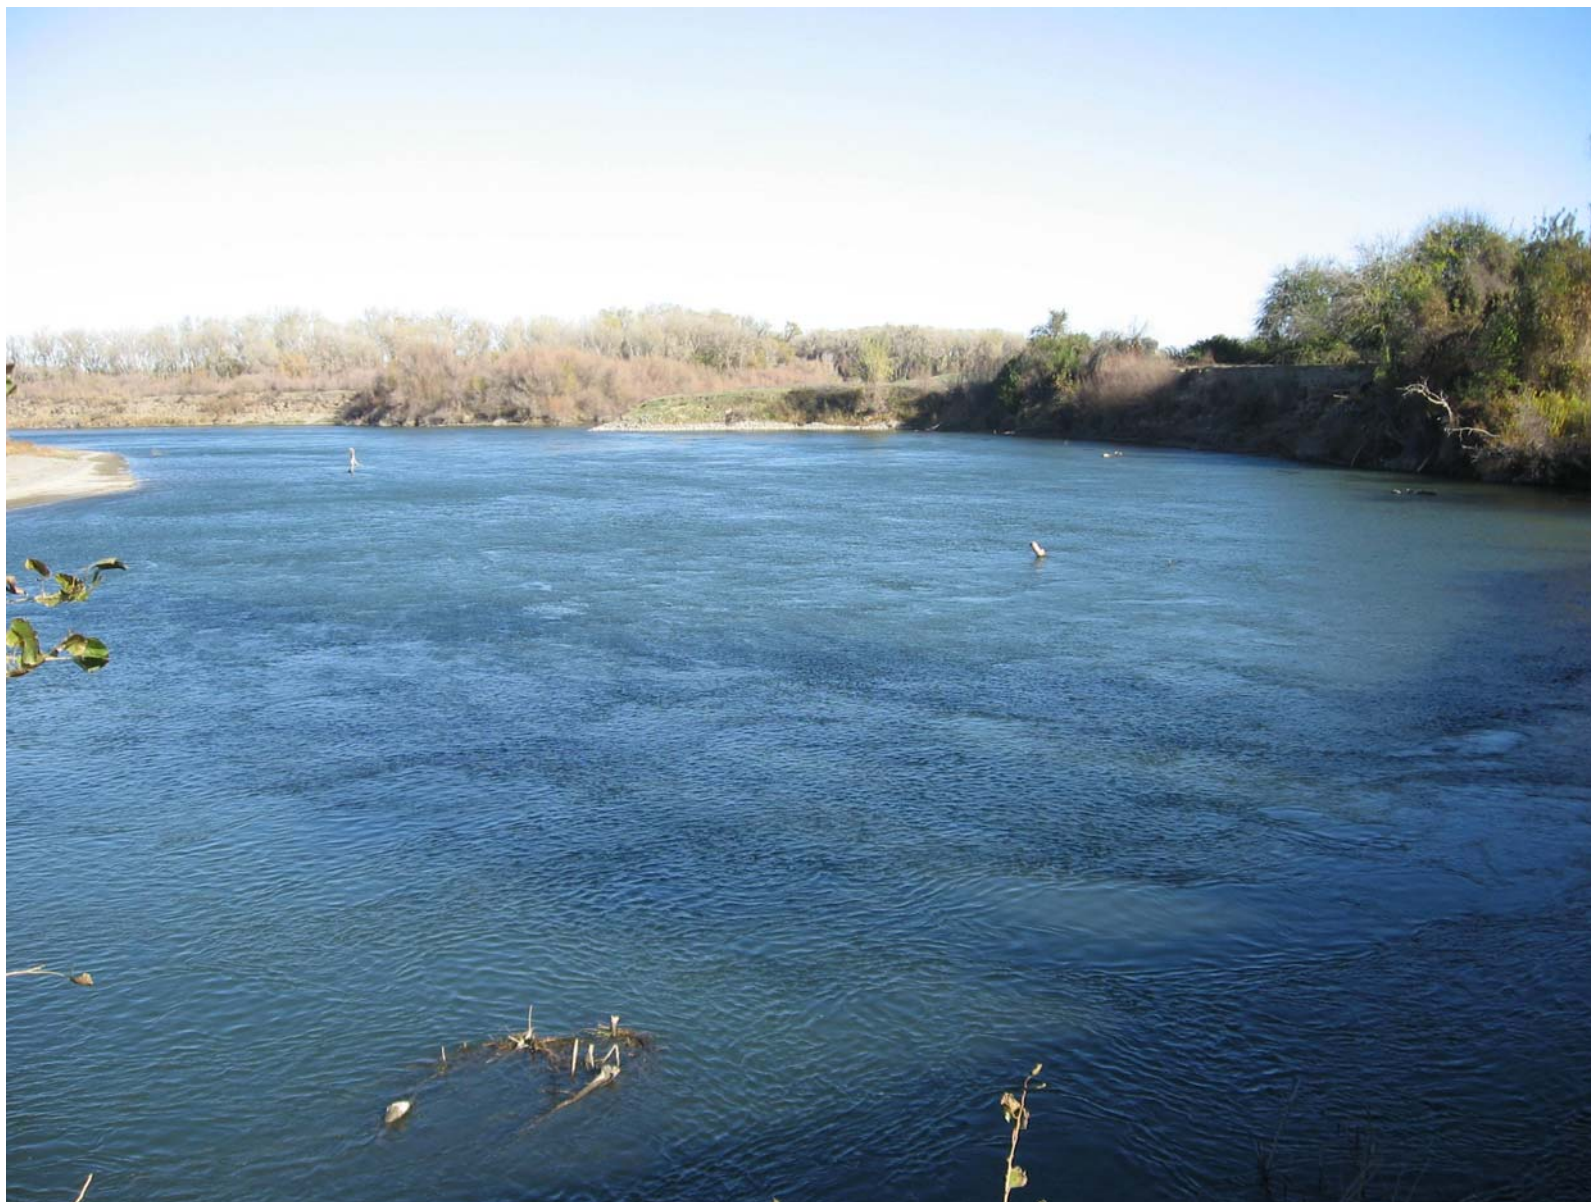
Photo  
5

Location 3 is protected by rock revetment within its upstream segment and by a setback levee at its downstream segment. Therefore, the upstream segment of the site is protected from erosion. The downstream segment may be subject to some bank recession, however, approximately 100 feet or more separate the bank from the setback levee, and therefore this segment is not in danger of losing flood protection.

Location 3 (looking N)

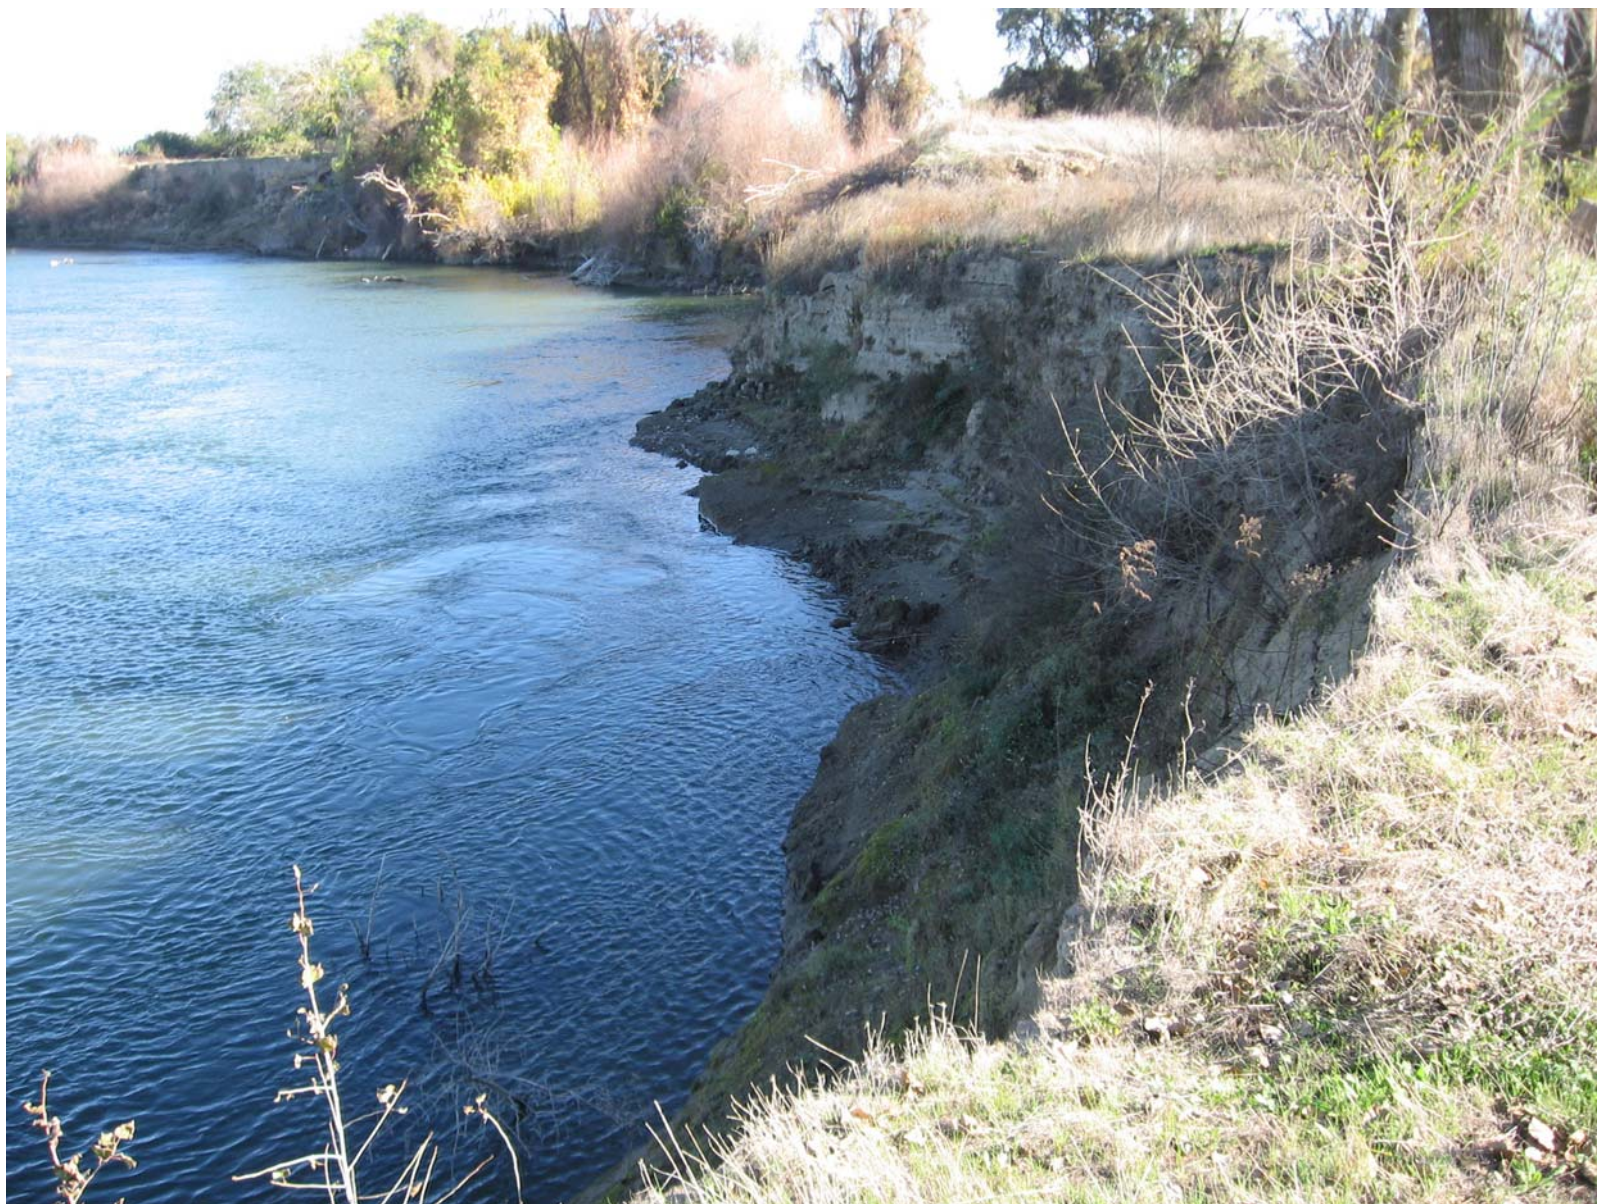
Photo  
6

Location 3 (looking NE)

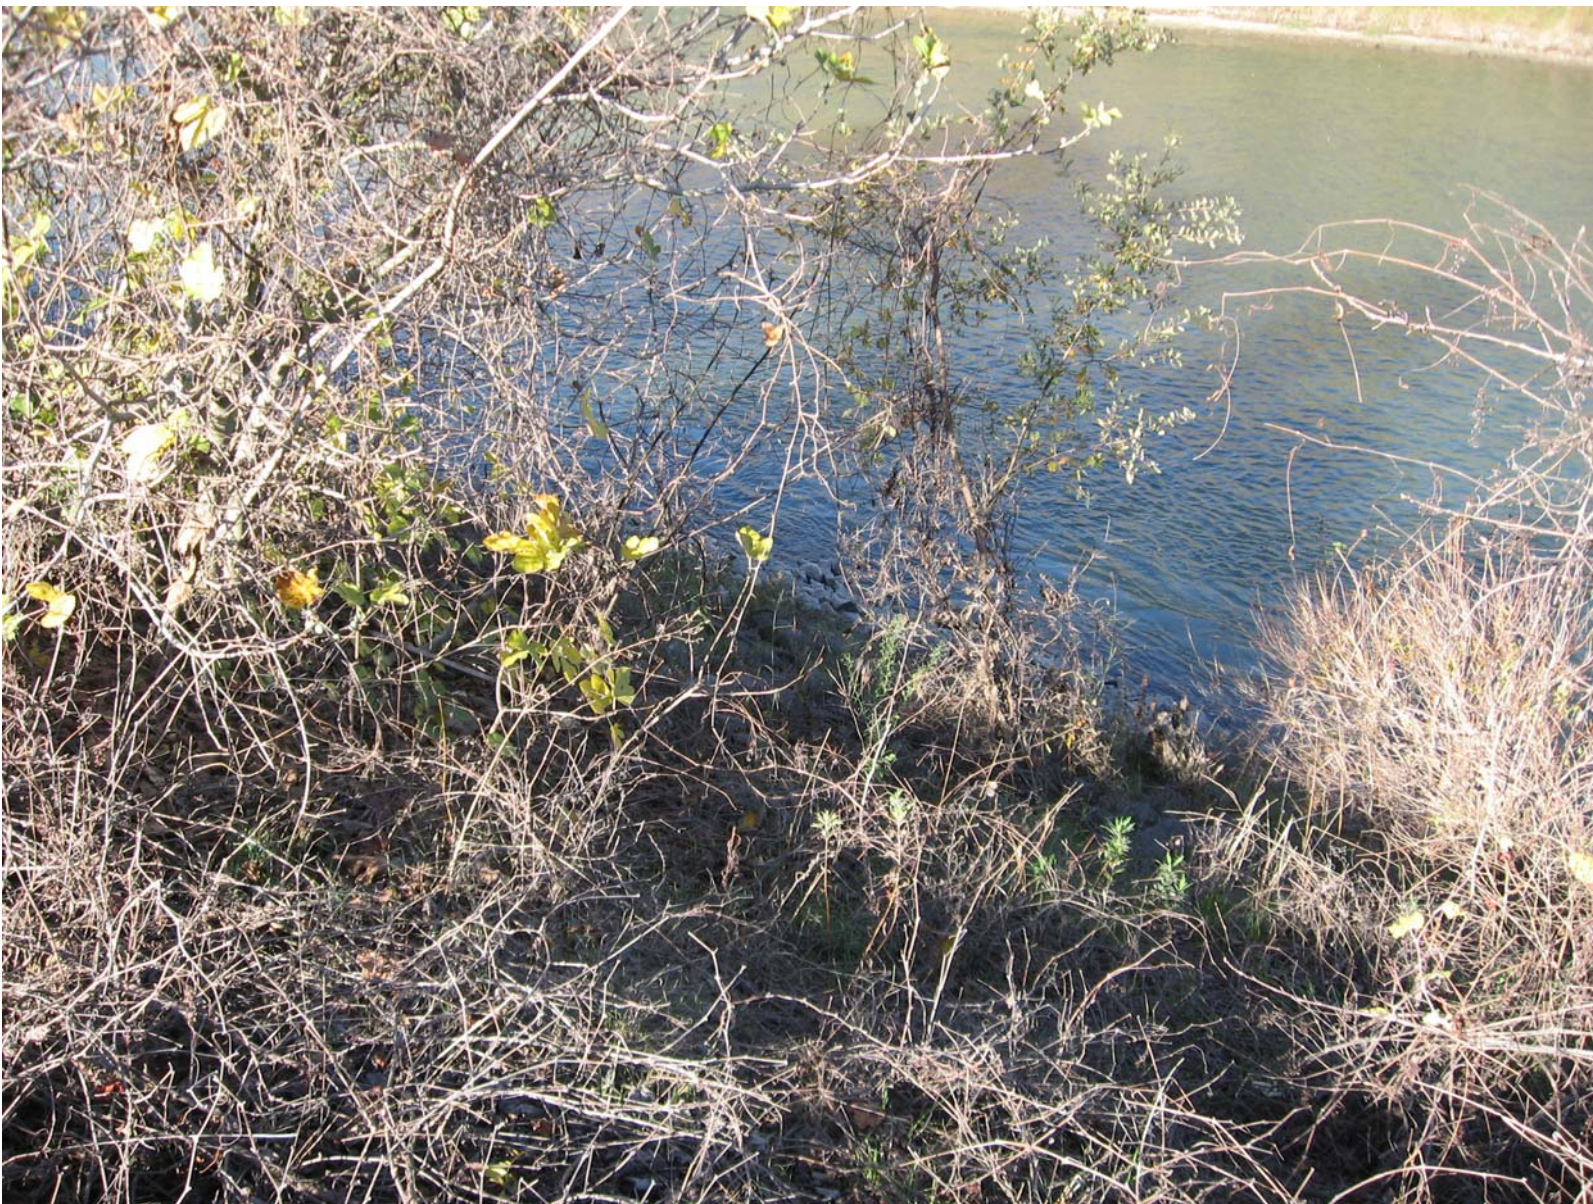
Photo  
7

Location 4 was evaluated in response to concerns raised by Ben Carter of the Reclamation Board due to the increased flow velocities that were modeled around the river bend near that location. The site was observed in the field to be covered with blasted rock revetment along its entire extent to within at least 10 feet of the levee crest. Mature vegetation exists on the slope and no erosion features were observed. Sutter Maintenance Yard personnel have not observed any problems at this location. Because of the lack of historical erosion issues at this location and the presence of revetment, Location 4 was determined to be safe from potential erosion due to the small flow velocity increases modeled to result from the proposed mitigation project.

Levee at Location 4 (looking downslope and W)

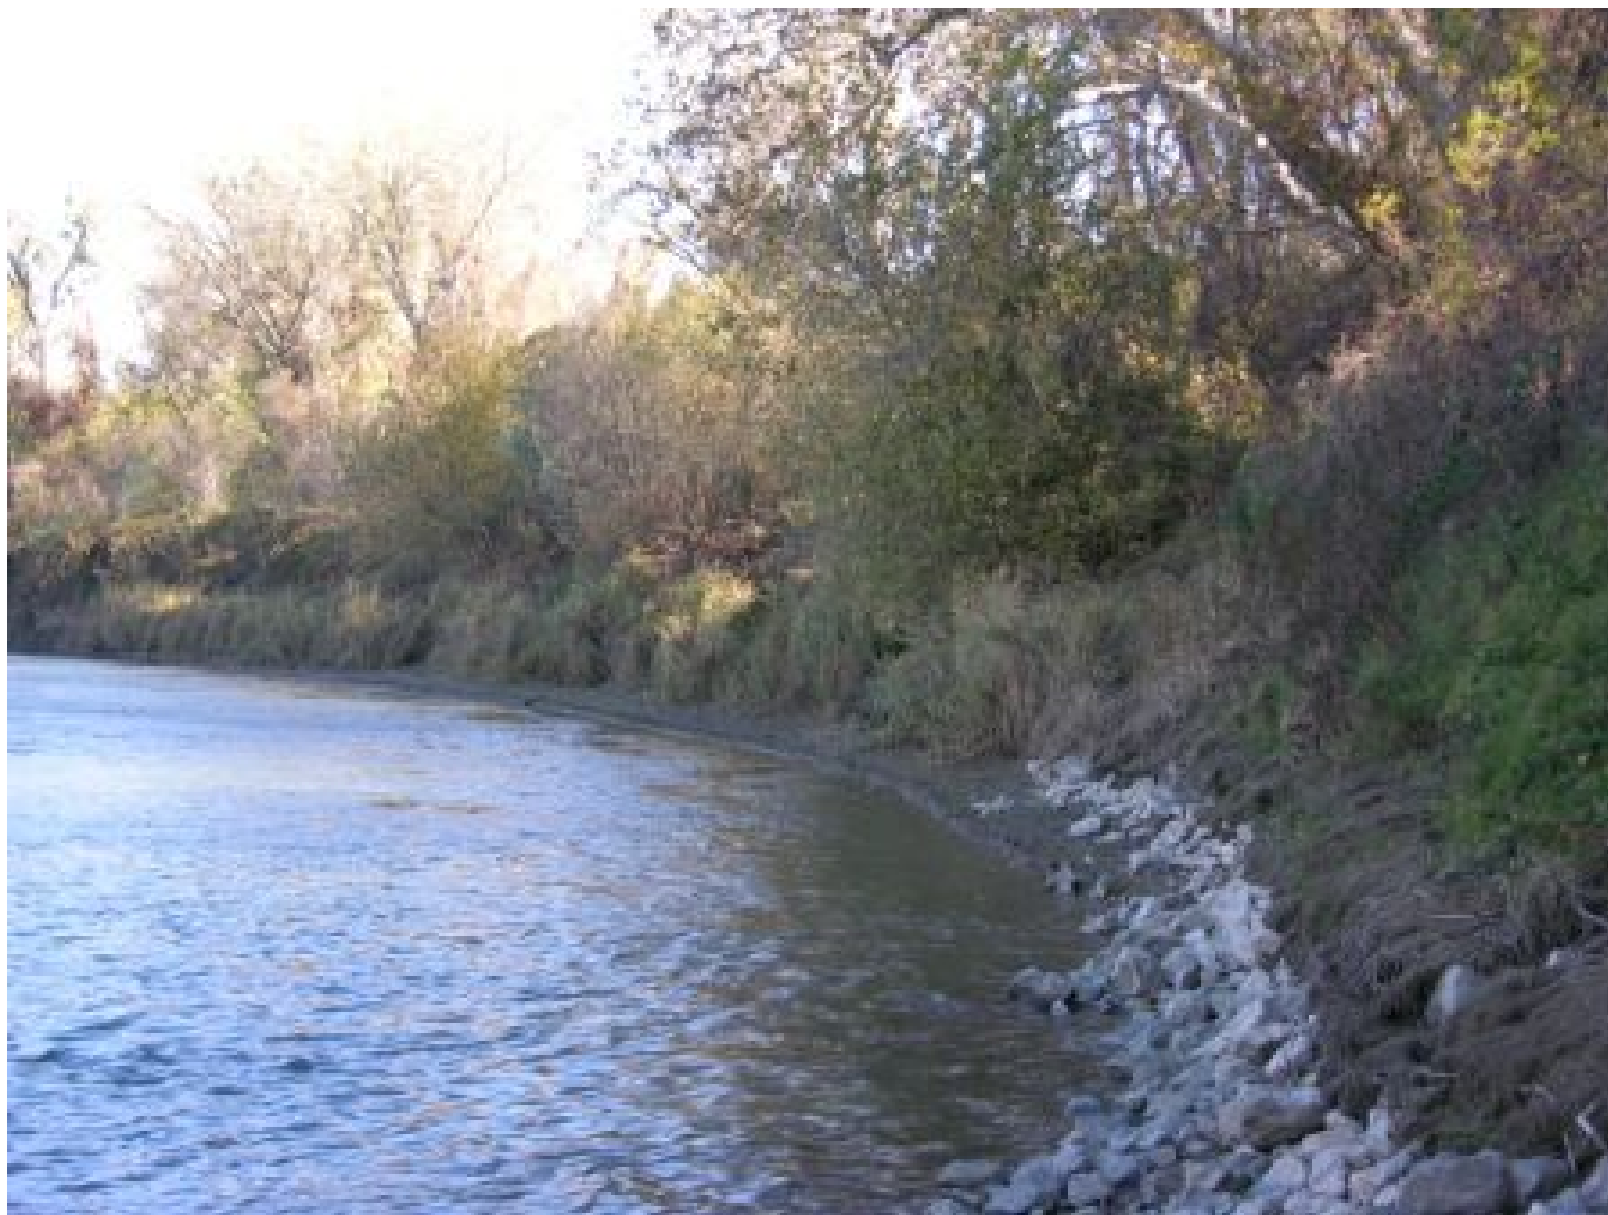
Photo  
8

Toe of Levee at Location 4 (looking NE)

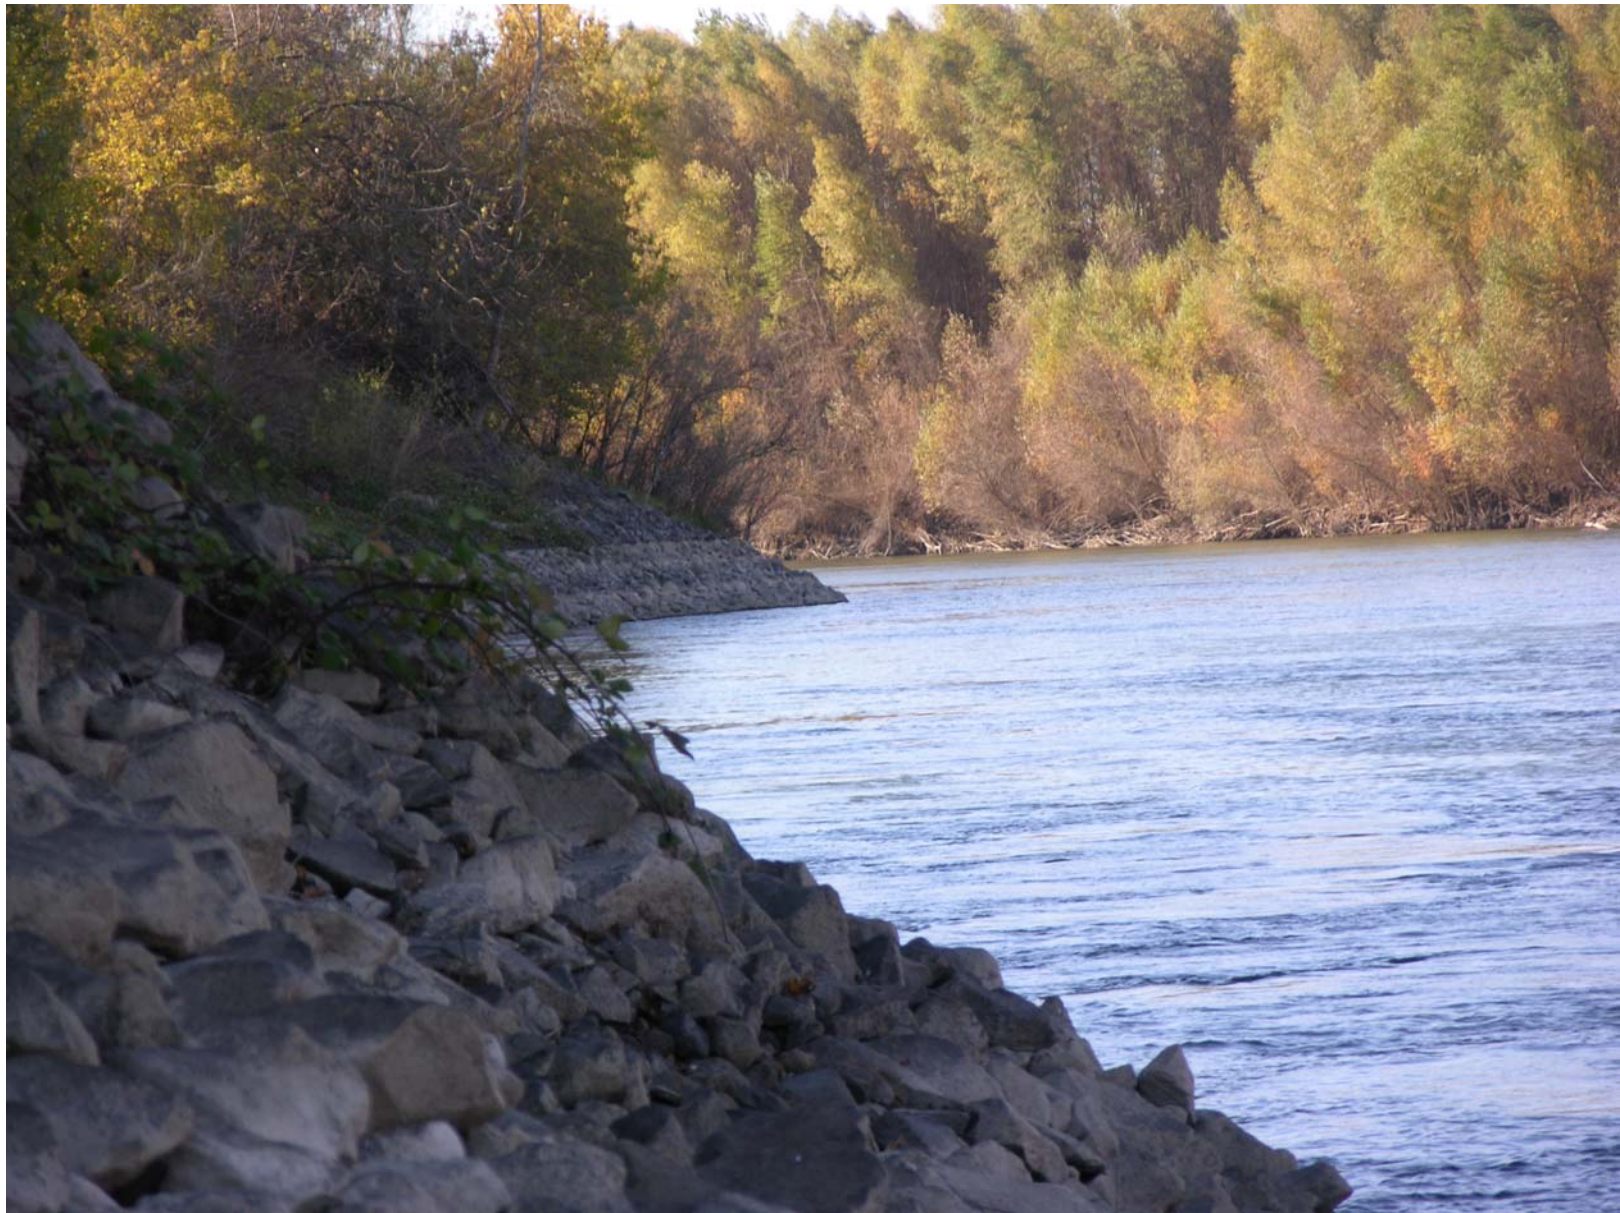
Photo  
9

Toe of Levee at Location 4 (looking SW)
